NUMBER 033

31/12/2009

## Renault 1.4 &amp; 1.6 16V / Synchronous Drive / Installation Info.

| <b>GATES REFERENCE:</b> | <b>5501XS, 5671XS &amp; related kits.</b> | |

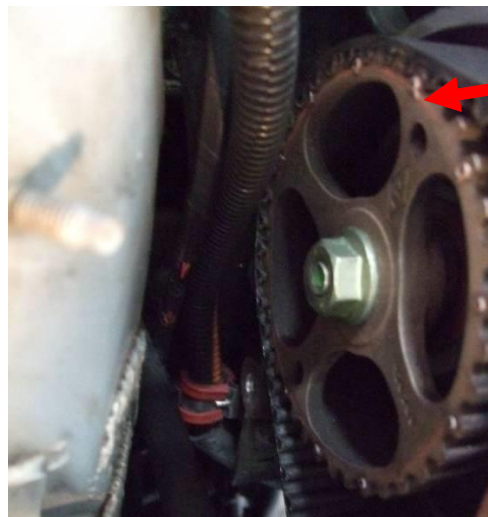
Fig. 1

In this drive, excessive play from the water pump bearing often occurs, this leads to belt tracking forward and forces the camshaft pulley flanges to detach and possibly enter the drive system. The result is belt failure. Also earlier mechanical damage to the flanges can lead to this (Fig.1). The camshaft pulley design has changed on these engines (but the OE ref. remained the same), in order to prevent this failure mode.

Flange detached

We always recommend servicing with a complete water pump kit. While changing the water pump, make sure the correct bolts/washers are used and torqued correctly.

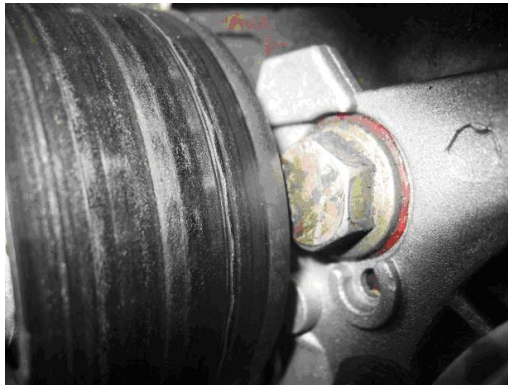
Fig.2

Fig. 2 shows the little space between water pump bolt and tensioner pulley.

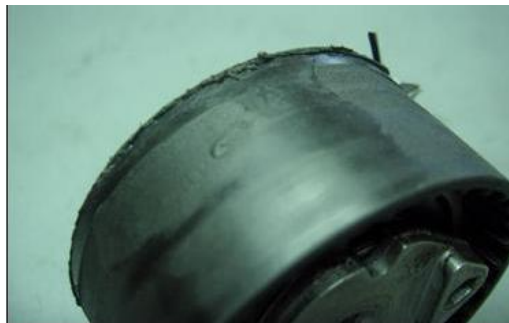
Fig. 3

Incorrect part or bolt coming loose leads to tensioner pulley contact (Fig. 3).

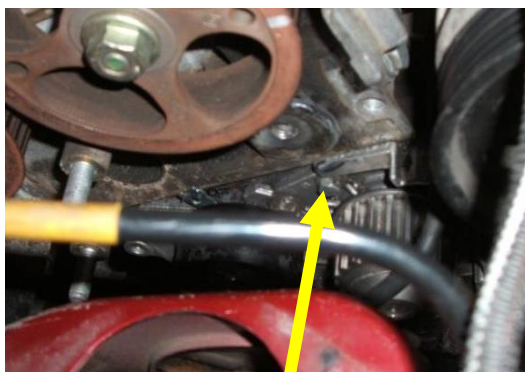
Fig. 4

While installing the new idler pulley, ensure that the spacer (sitting between the old pulley and the engine block) is re-fitted between the new pulley and the engine block. If not, the idler pulley can touch the water pump, causing idler and belt failure (Fig. 4 and 5).

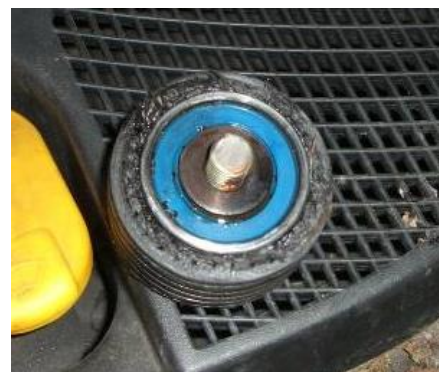
Fig. 5

Rubbing mark

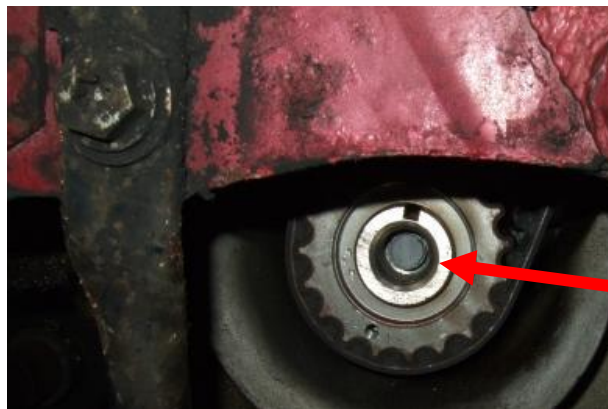
Fig. 6

The crankshaft bolt can't be re-used. (OE ref. is 8200557644. This is supplied with the kit). The correct torque setting of this bolt is very important and varies per engine code or model. Incorrect torque causes bolt shear. (Fig. 6)

Bolt sheared

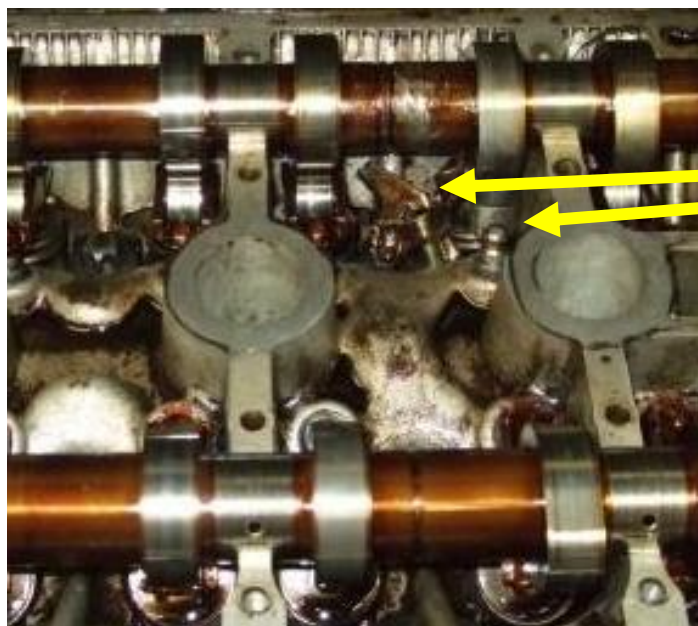
Fig. 7

In the event of an engine repair, after piston to valve contact, a close inspection of the camshaft rockers is essential. It is possible that rockers sustained damage. If so, the rockers must be replaced. Neglecting their replacement causes seizing of the camshaft. (Fig. 7)

Rocker broken
