Damage to vacuum pumps through incorrect assignment

Vehicle	Product: Vacuum pump	
	PIERBURG No.	O.E. No.*
VW Transporter LT, T4 (pickup, window van, panel van, California) Engine code: AAB	7.22300.62.0	075 145 100 ; 075 145 101; 075 145 101 A
	7.22300.69.0	074 145 100 A

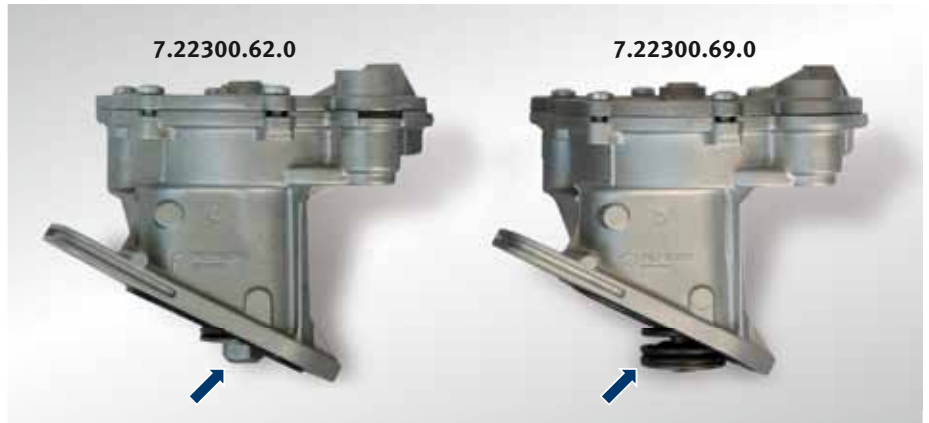
Fig. 2: Vacuum pump comparison

Due to a change of the cylinder head in the case of the VW T4 engine with engine code AAB the vacuum pump has frequently been incorrectly assigned.

7.22300.62.0	7.22300.69.0
Replacement for	7.22300.12.0	7.22300.19.0
Year of manufacture	to 5/1994	from 5/1994
Vehicle identification number	to 70-R-180 000	from 70-R-180 001
VW part number	075 145 100, 075 145 101 075 145 101 A	074 145 100 A
VW cylinder head No.	074 103 351 A	074 103 351 D
MSI cylinder head No.	50 003 101	50 003 113
Cylinder head cover surface	11 bores; Ø 5mm	no bores
PIERBURG tappet rod number	3.52124.06.0	3.52124.05.0
VW tappet rod number	075 145 307	074 145 307 B
Tappet rod length	71,0 mm	67,5 mm

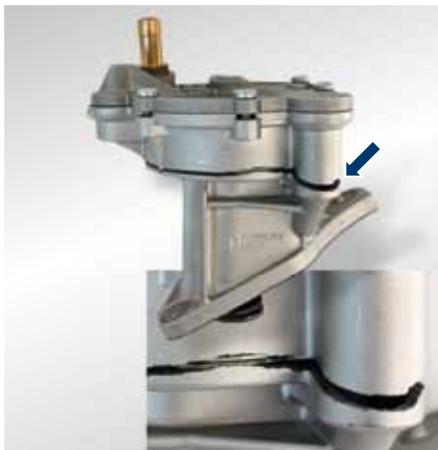
Fig. 1: Broken pump casing

! Mounting the wrong pump will “immediately”, upon starting the engine for the first time after installing the vacuum pump, cause the pump casing (see Fig. 1) to break or even the camshaft may break thereby resulting in severe and expensive engine damage.

In order to prevent damage, a precise check of the vehicle data is essential. We recommend to check in any case the assignment through the vehicle identification number!

! Under all circumstances check

- vehicle identification number
- registration date and/or
- part number of the old pump!

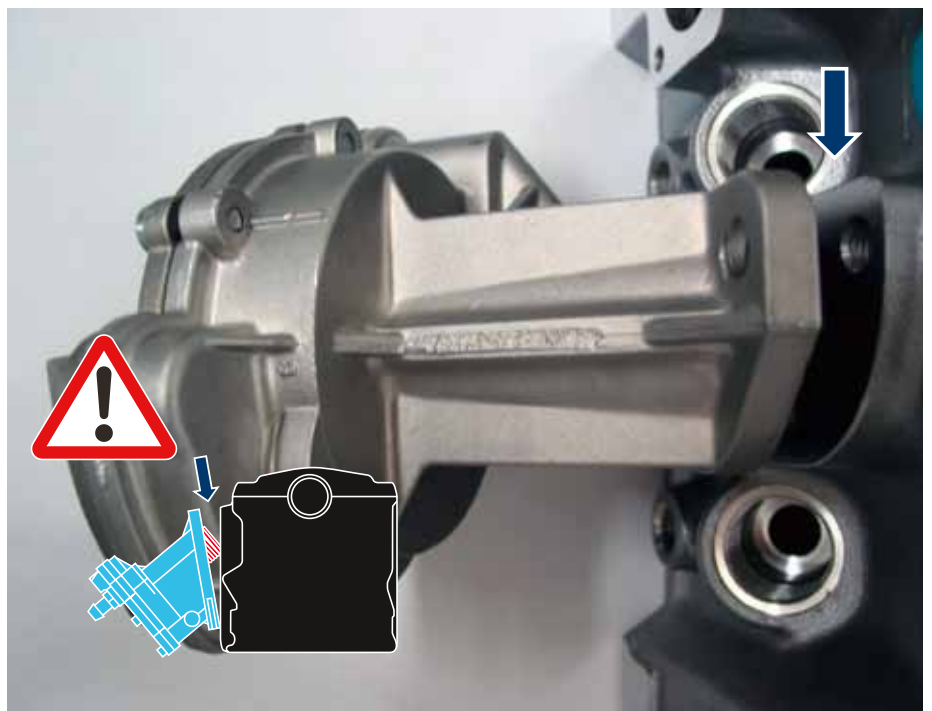
Fig. 5: In the case of a wrong assignment, proper installation will not be possible

Wrong assignment – installation not possible

If the vacuum pump cannot be pressed onto the flange without exerting a significant amount of force (gap 5 mm approx.) although the cam is located at the opposite side of the intermediate tappet rod you can be sure that the assignment is wrong.

- !** Under all circumstances check
- vehicle identification number
 - registration date and/or
 - part number of the old pump!

- !** Never try to resolve this problem by modifying the intermediate
- tappet rod (by grinding, for example)
