## Issue No. 8/2013: Problems following a filter change? Tips for fitting the MAHLE fuel filter KX229D correctly

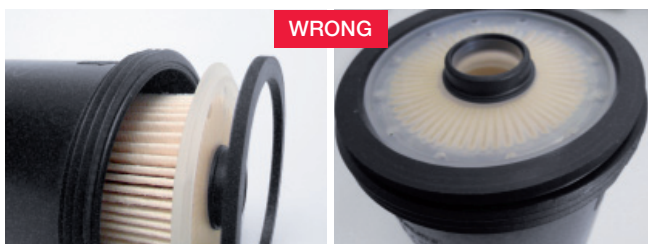
If fitted the wrong way round, leaks will occur in the system, which may lead to the intake of air and to starting problems or a fuel leak.

Figure 1: wrong order

**IMPORTANT: THE CORRECT FITTING ORDER OF THE SEAL AND FILTER ELEMENT TO THE HOUSING AND COVER.**

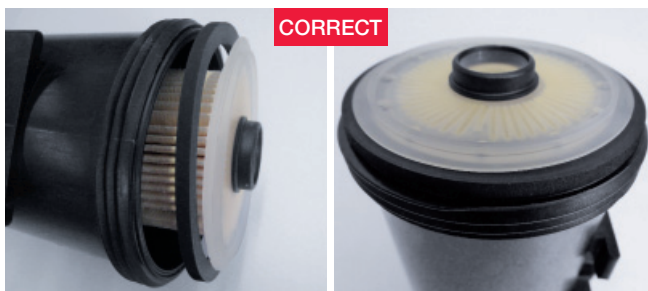
Figure 2: correct order

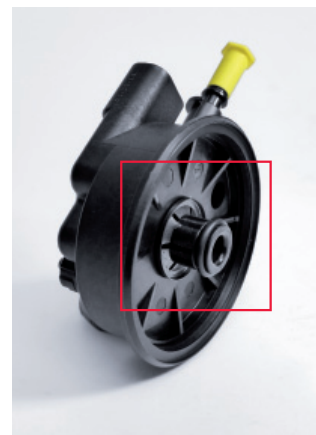
Figure 3: correctly positioned gasket

**Our tip: with every filter change, please ensure that the sealing ring is correctly seated on the housing cover!**

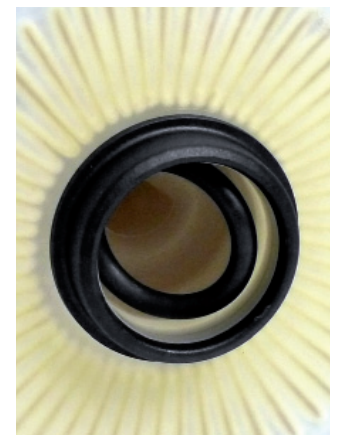
If the sealing ring becomes detached from the cover during dismantling, it can remain inside the filter element and be disposed of with the old filter. If this is not noticed, unfiltered fuel will reach the injection system during operation. Caution: the harmful consequences of this installation error are not immediately detectable; however, wear on the fuel system is continuously increased.

Figure 4: gasket stuck in the filter gasket
